Maywood Public Library District 2023-2033 Capital Needs Assessment

FINAL - August 2023

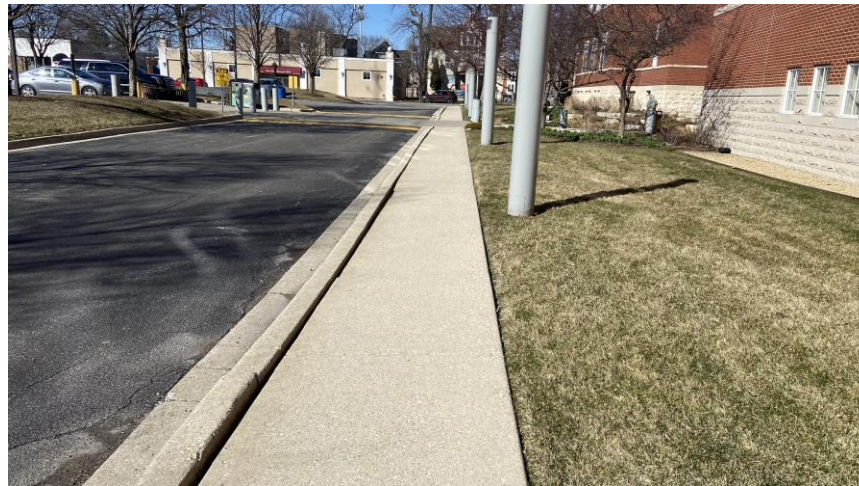
Fig. 1- Sidewalks separated from curb, resulting in large gap and level change at curb.

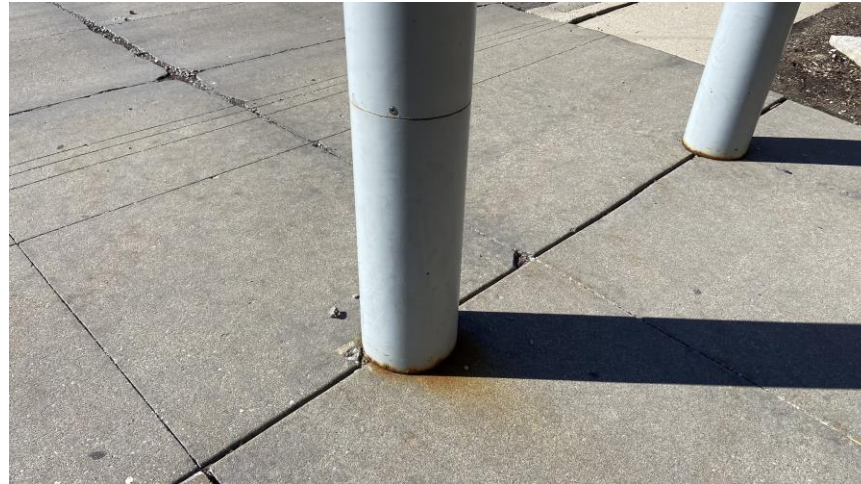
3. Light bollards are severely corroded at locations in concrete, likely due to sidewalk salt exposure. They should be replaced with new lighted bollards with corrosion-resistant bases and LED lighting or eliminated altogether.

Fig. 2- Corroded light bollard bases.

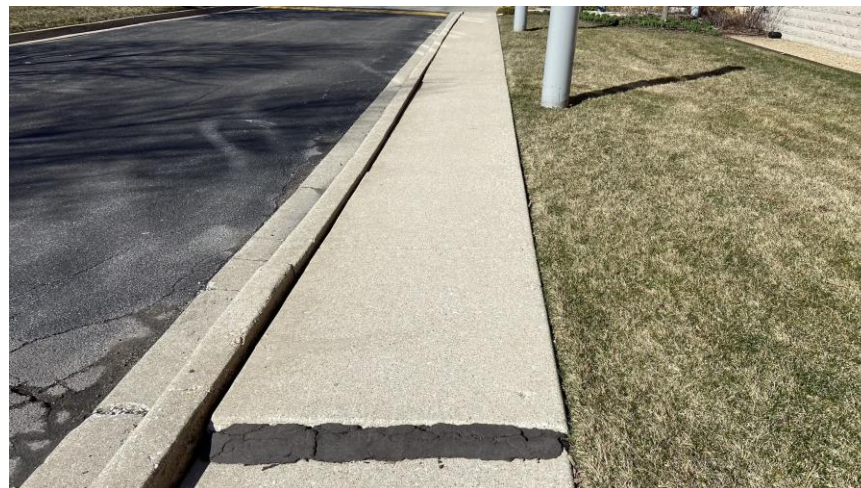
4. Some areas of concrete sidewalks are severely damaged and cracked, requiring removal and replacement.

Fig. 3- Damaged/cracked sidewalk areas.

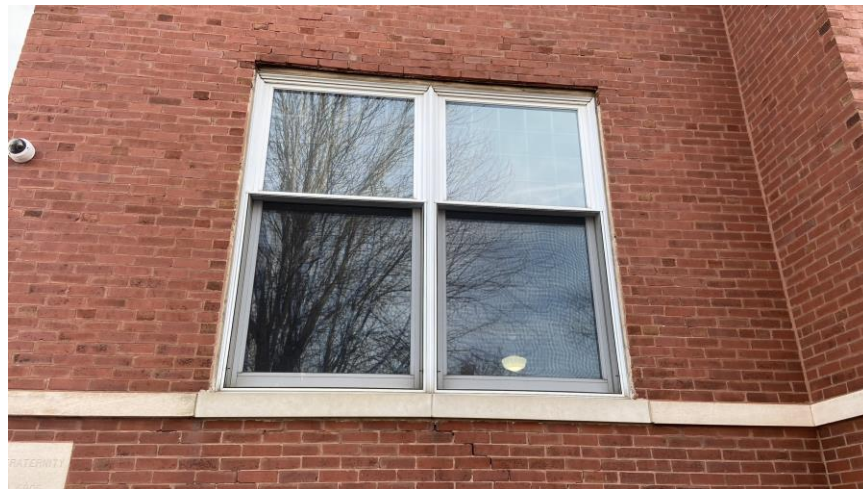
1. Lintels above windows in the Carnegie portion of the building are severely corroded, with masonry damage above and around each lintel location. The cause of this damage is most likely water infiltration from above attempting to escape the wall assembly. Since no flashing that can direct moisture out of the building exists, freeze-thaw cycles force moisture out of the building through the masonry. Each location will require installation of a new lintel and repair of the damaged masonry above each lintel.

Fig. 5- Example of masonry damage and lintel corrosion above window in Carnegie portion of building.

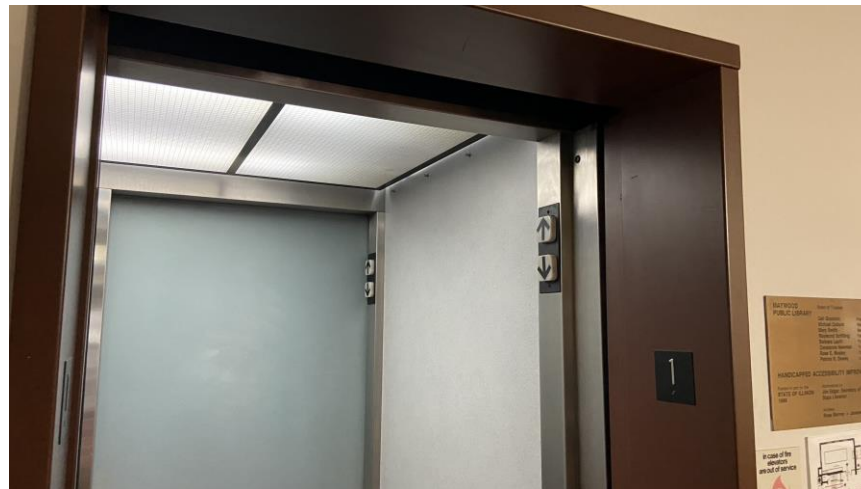
1. Both hydraulic elevators in the facility are at least 25 years in age and are within ten years of their expected remaining service lives. No records were available to confirm the age of the elevator in the Carnegie portion of the building, though it appears to have been present when the building was expanded. Though there are no known operational issues with the elevators currently, modernization of the controls, replacement of machinery, and replacement of cab finishes is recommended within the next 10 years to avoid sudden and unpredictable maintenance and repair costs. The elevator in the Carnegie portion of the building should be prioritized as it is older and known to have obsolete components. Replacing the annunciators (the portion of the elevator that sounds a tone at each level) is recommended when this project is undertaken is recommended to comply with current audible signaling requirements for elevators within the Illinois Accessibility Code.

Fig. 6- Elevator door and cab at Carnegie portion of building

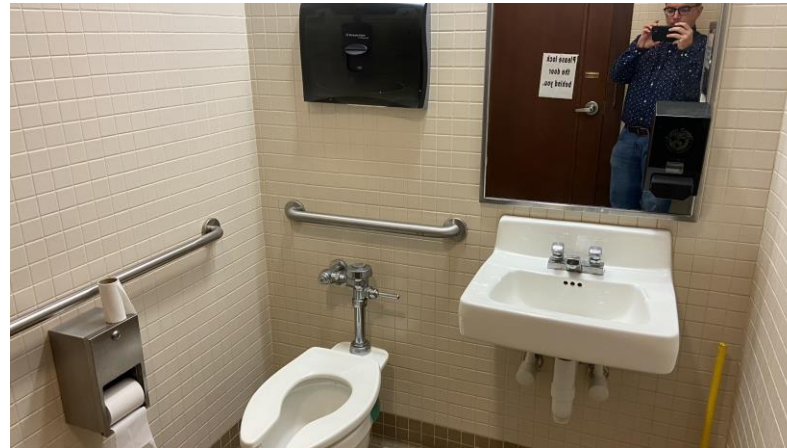
- Restrooms are compliant with the version of the Illinois Accessibility Code that was in place when the building was expanded and remodeled but are not compliant with current codes. Future renovations to restrooms may trigger compliance with current code requirements which will require single-user restrooms to be made larger to allow for adequate side transfer space for the toilet. The grab bar in both single user restrooms in the original portion of the building are 12" shorter than required to meet current codes.

Fig. 7- Inadequate side transfer space and rear grab bar length.

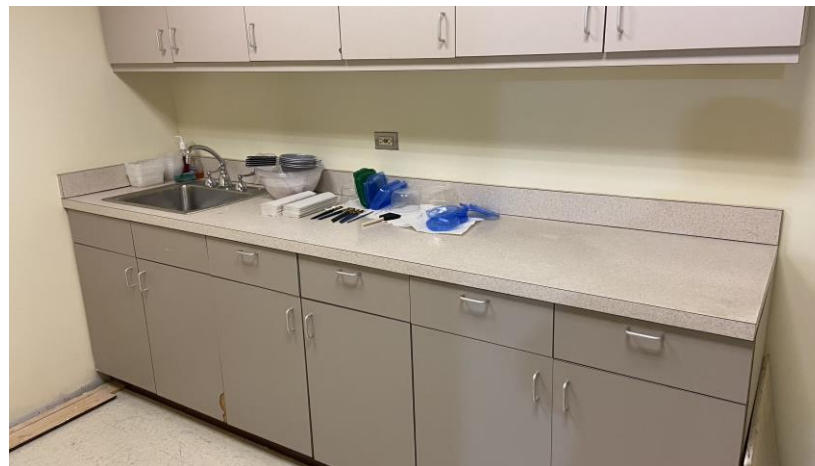
- Sinks at employee break areas and public areas do not have knee space underneath as required by current accessibility codes. Since most of the casework at these areas is in poor condition, knee space should be provided in conjunction with cabinet/counter replacement.

Fig. 8 - Lack of knee space at staff and public area sinks.

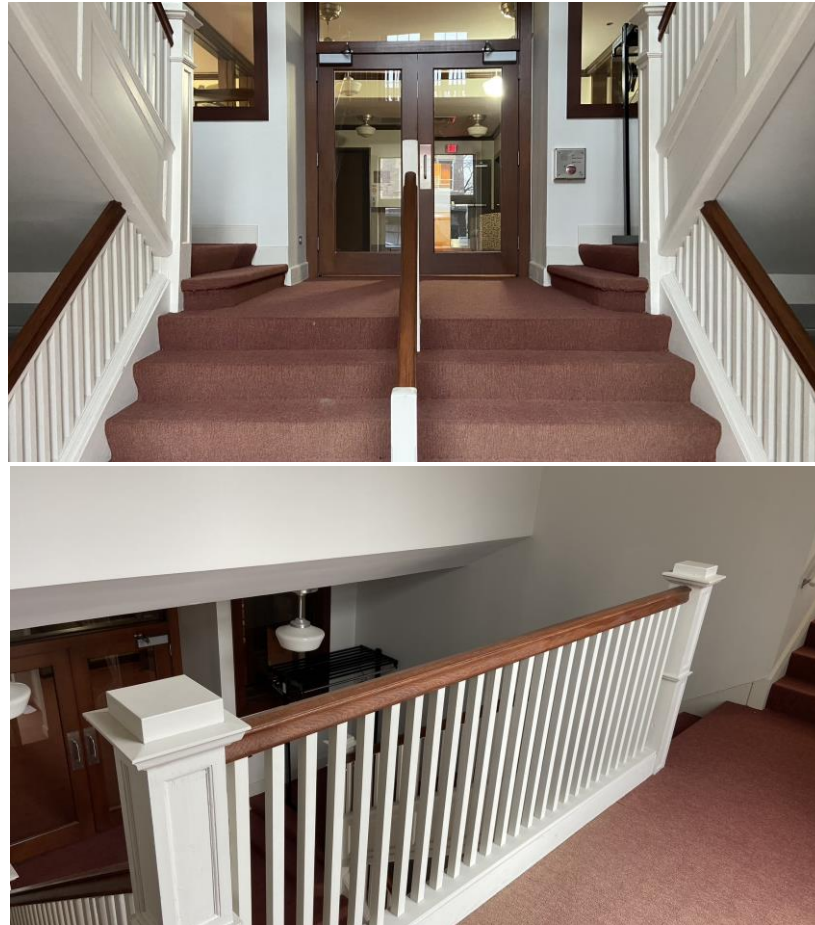
1. Handrails and guardrails at stairways within the Carnegie portion of the building are non-compliant with current building codes for height, continuity, and profile. They are not required to be upgraded as existing components not being altered as long as use of space does not change.

Fig. 9 & 10 - non-compliant handrails and guardrails at original portion of building.

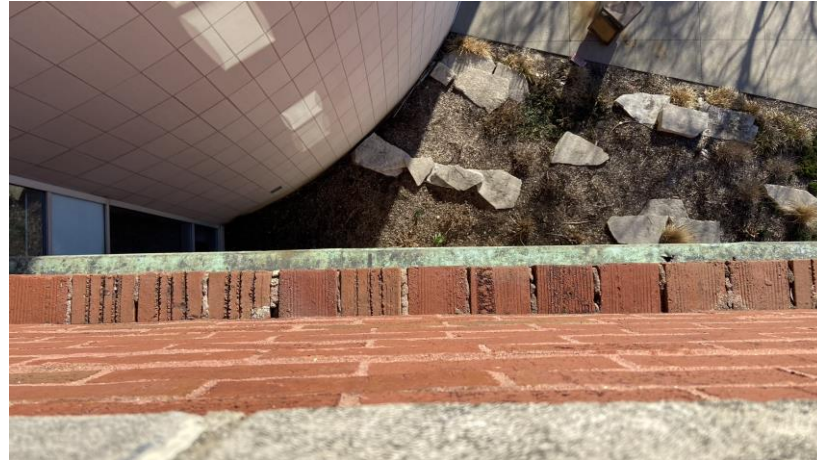
1. Severe deterioration of masonry (brick and stone) is evident throughout the original Carnegie portion of the building from the exterior, most likely from water infiltration and freeze-thaw cycles. Unlike buildings of current vintage that are required by codes to incorporate provisions for moisture management and drainage, the original portion of the building has no drainage paths or flashings allowing moisture to escape; therefore, once water enters the wall assembly it tends to stay there until forced out by freeze-thaw cycles. There is significant mortar loss and, in some cases, cracked and spalled masonry, further contributing to moisture intrusion. The entire building will require mortar restoration through tuckpointing, replacement of damaged masonry to match existing, and cleaning to maintain structural integrity and stop further deterioration. As previously noted in the Structural section of this Assessment, observation of the foundation as well as observation of masonry walls and lintels from the interior of the original portion of the building are recommended to assess for further currently unobservable damage.

Fig. 11 - mortar loss as viewed from Carnegie portion roof

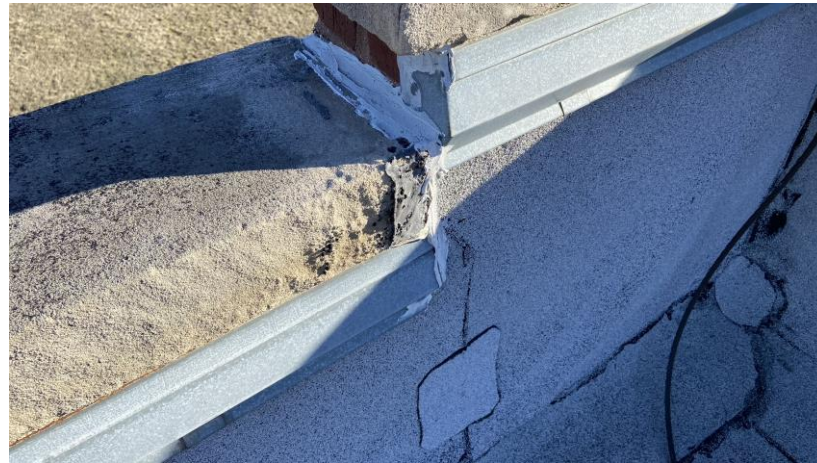
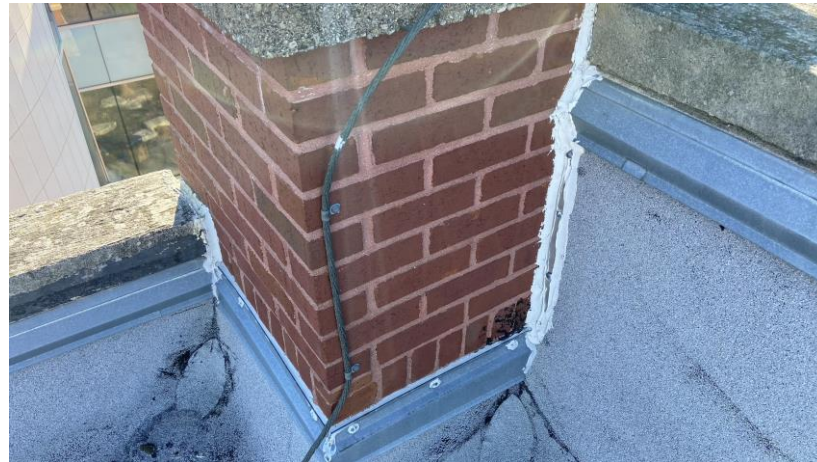
2. Several critical wall-roof junctions of the Carnegie portion of the building appear to have had more recent sealant repairs, indicating known water intrusion issues.

Figs. 12 and 13 – areas of sealant repair at various wall-roof intersections.

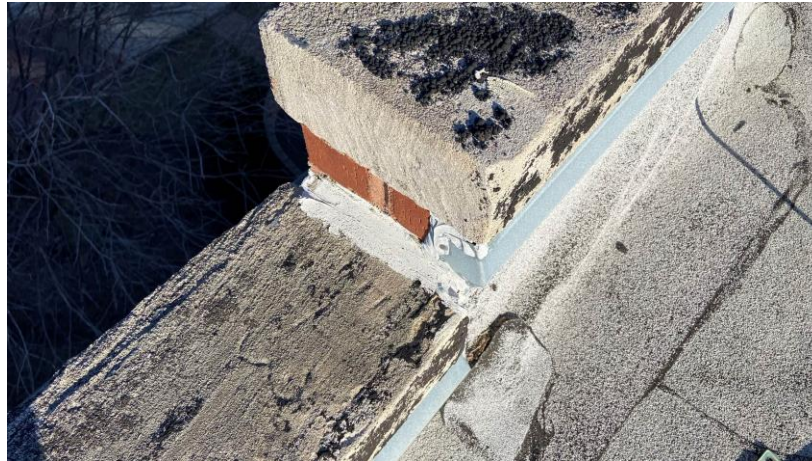
3. The original stone cap on the Carnegie portion of the building is severely degraded and stained and has a black residue in many locations. Further investigation is needed to determine the source of the black residue (it may be a mastic from a previous metal coping over the stone from a past roofing project)

Fig. 14 - stone cap degradation and black residue observed in several locations.

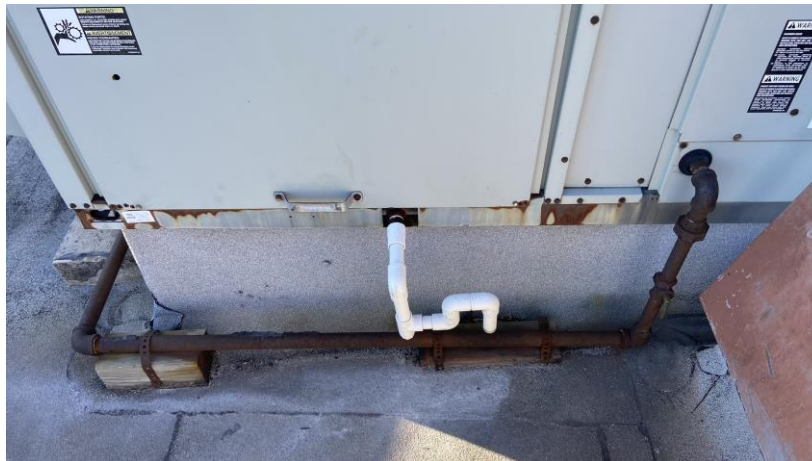
4. Condensate drains directly from rooftop cooling units onto roofing surfaces, sometimes creating ponding conditions which increase the chance for water intrusion through the roof. These should be piped as close to roof drains as possible.

Fig. 15 - condensate drain from HVAC units onto roof surface.

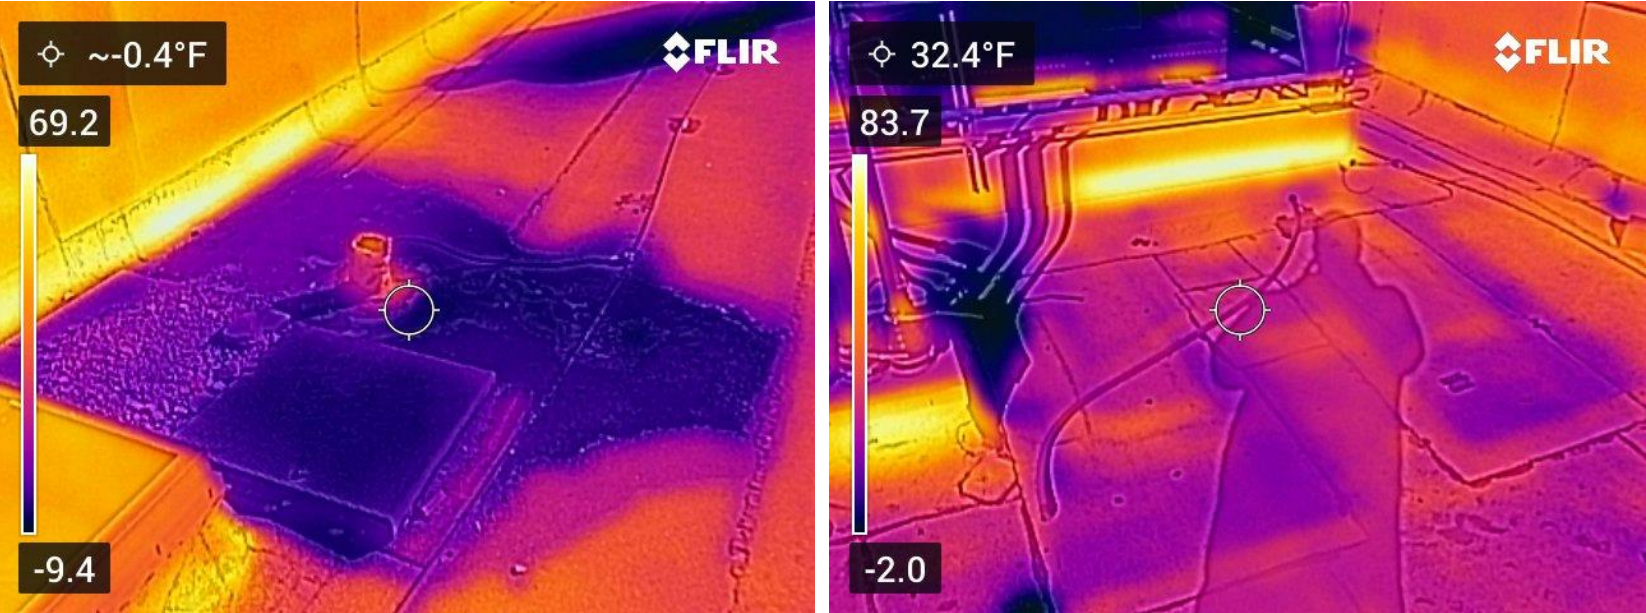
5. The roofing system on both the Carnegie portion of the building as well as the addition is a modified bitumen system. These systems are high-quality systems that can last up to 35 years and most of the roof is in good condition. Our team used an infrared camera to assess areas of saturated roofing which would indicate areas of partial or total roofing system failure. Some areas of modified bitumen roofing are soft under foot and thermal imaging confirms saturated insulation underneath the roofing system. This is most evident around both roof hatches and to a lesser extent around HVAC units where the roof is not pitched enough to drain water away. These areas should be cut out and replaced with new insulation and roofing.

Figs. 16 and 17 - saturated insulation areas at addition and original portion of the building

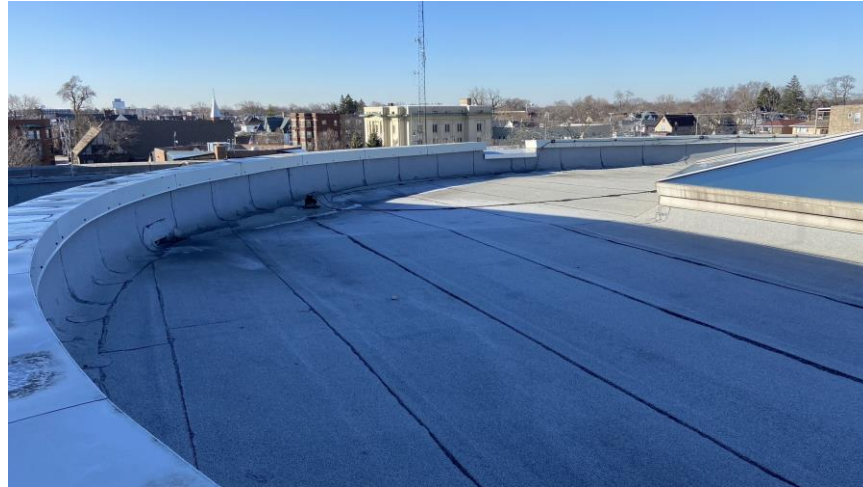
6. As the existing modified bitumen roof is approximately 25 years old and experiencing some areas of failure, replacement of the entire system should be considered within the next ten years. The system can be replaced with a similar system or another type of roofing with a thirty-year warranty. Tearing off the roof and insulation down to the structural deck would provide additional insulation increasing the energy efficiency of the structure.

Fig. 18 - modified bitumen roofing system at building rotunda.

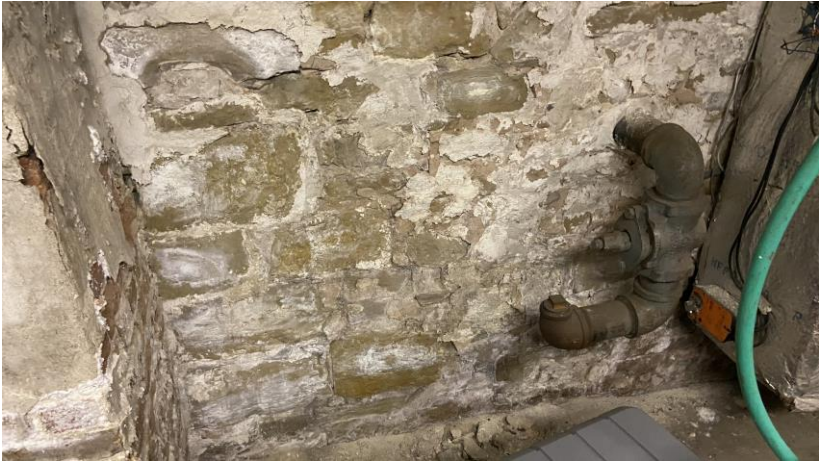
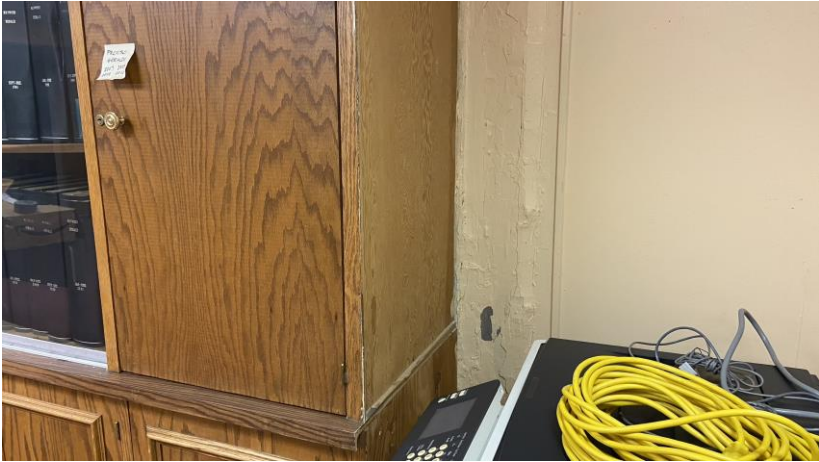
8. The basement of the original portion of the building shows several signs of water intrusion and efflorescence. Though there are no known active leaks, the foundation wall should be exposed and observed from the exterior to evaluate any currently unobservable structural or water intrusion issues.

Figs. 19 and 20 - indications of water intrusion in basement of Carnegie portion of building

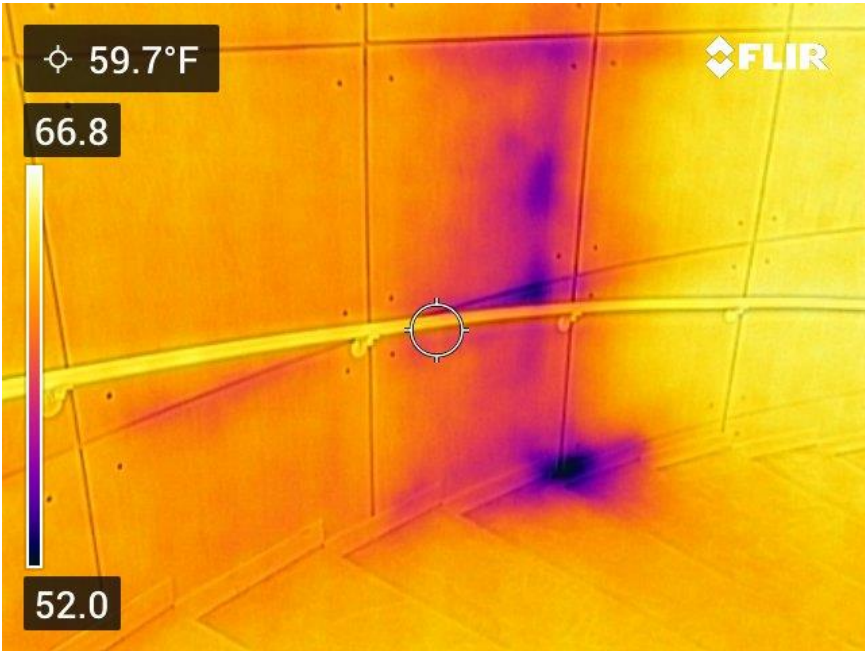
9. As previously discussed, our team used a thermal imaging camera to assess for any potential areas of moisture intrusion that may be undetectable to the naked eye. One finding of concern is at the north wall of the rotunda, which shows a temperature differential in a very specific area. Given that the temperature difference measured is only about 15 degrees, there is a possibility that only a very minor issue exists at this location. Removing a wood interior panel at this area to assess for damage and making repairs as needed is recommended to mitigate any potential unseen damage.

Fig. 19 - "cold spots" indicating possible moisture intrusion at rotunda interior.

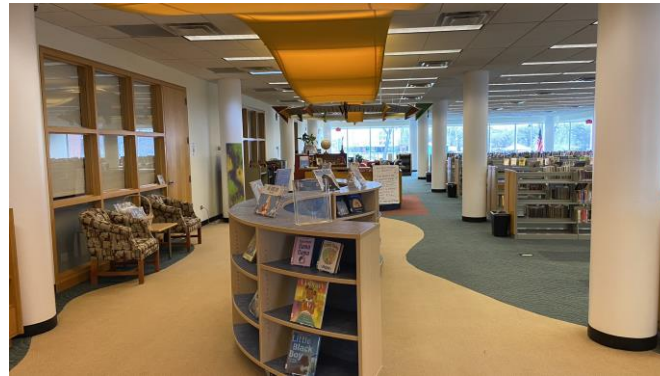
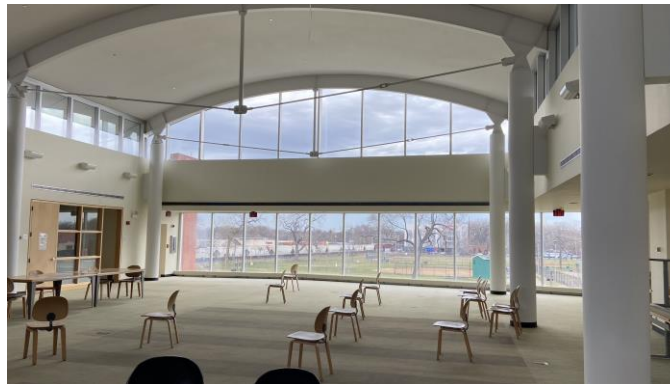
1. Though many interior finishes are original to the 1998 building addition or before, most are in very good condition. This is likely due to good cleaning practice and to some extent lack of heavy use. However, some finishes - particularly second and third floor carpeting in the addition of the building - need replacement from a combination of wear and fading from sun exposure.

*Figs. 20 and 21 - second and third floor carpet in need of replacement.
(The third-floor carpet replacement could be deferred if the space will continue to be unused)*

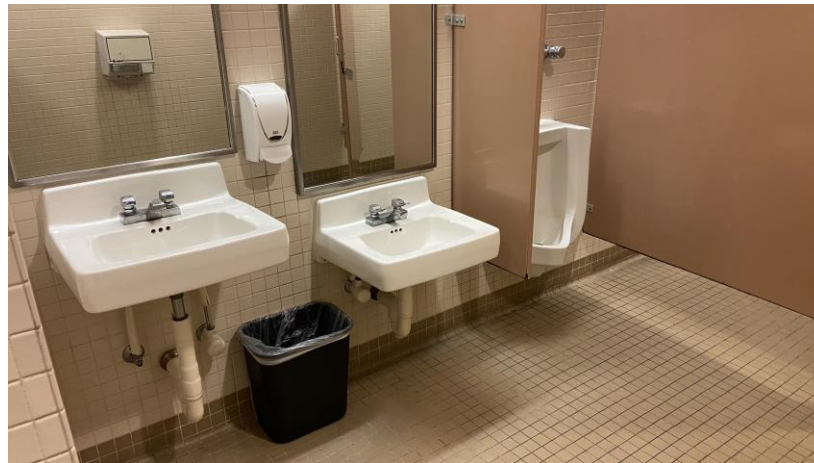
1. Some plumbing fixtures in public restrooms are worn and require replacement with new fixtures within the next five years. Most of the public restroom faucets are spring-actuated with separate hot and cold supplies; replacement of these faucets with sensor-activated single temperature faucets with thermostatic mixing valves is recommended in all restrooms for safety purposes. The Library may also consider introducing sensor-actuated flush valves at toilets and urinals for hands-free operation.

Fig. 23 - public restrooms with older fixtures and spring-actuated faucets.

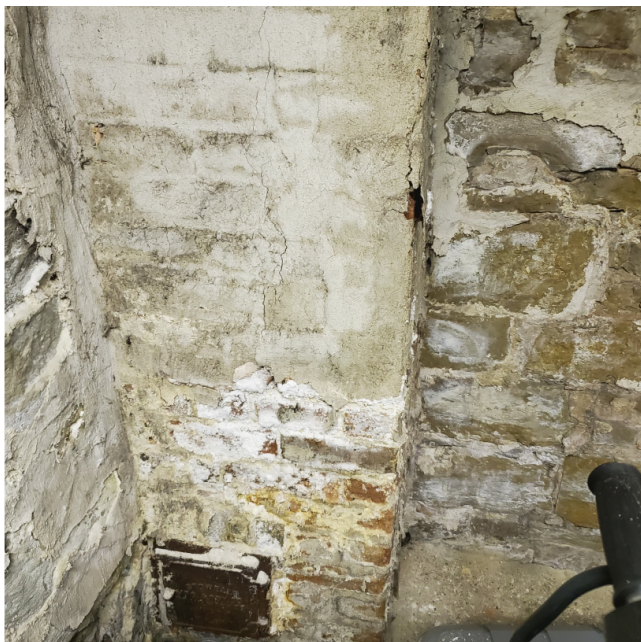
We were informed that the basement has issues with moisture at several locations throughout the basement. While most of the basement foundation walls are covered with finishes, the existing stone foundations that are exposed to view, are exhibiting signs of water infiltration. The efflorescence is very evident in much of the brick masonry, which is an indicator of moisture in the wall assembly.

Interior Stone Foundations with Efflorescence

It is our opinion that the existing stone foundations of the Carnegie building are not exhibiting signs of excessive settlement, and that the exposed foundations are in fair condition, although signs of water infiltration are evident from the basement side of the foundations. For the remediation of the water intrusion, it is recommended the exterior of the Carnegie building be excavated to expose the existing stone foundation walls. In exposing the foundations, a more complete assessment can be made regarding the condition of the structural integrity of the foundations. After any required foundation repairs are made, a water-proofing membrane is to be installed on the outside face of the foundations walls, prior to backfilling.

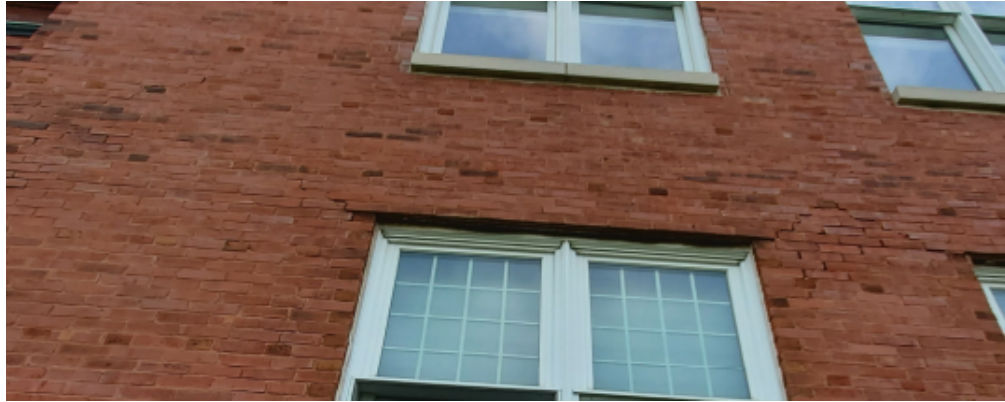
The exterior of the Carnegie building is exhibiting cracking in the brick masonry walls at several locations. We noted that most of the existing steel lintels above the window openings are heavily corroded, and we believe that the lintel corrosion is the primary cause of the cracking in the exterior brick walls. As the steel lintels corrode, the steel expands and this expansion pushes the exterior brick wythe and causes the cracking. The existing steel lintels above the windows do not appear to be protected from the elements by either painting or galvanizing.

Cracks above Windows Due to Lintel Corrosion

It is also recommended the existing corroded steel lintels be replaced with new galvanized steel lintels. After the replacement of the steel lintels, repairs, such as tuck-pointing, should be made to the exterior brick masonry walls to reduce water infiltration.

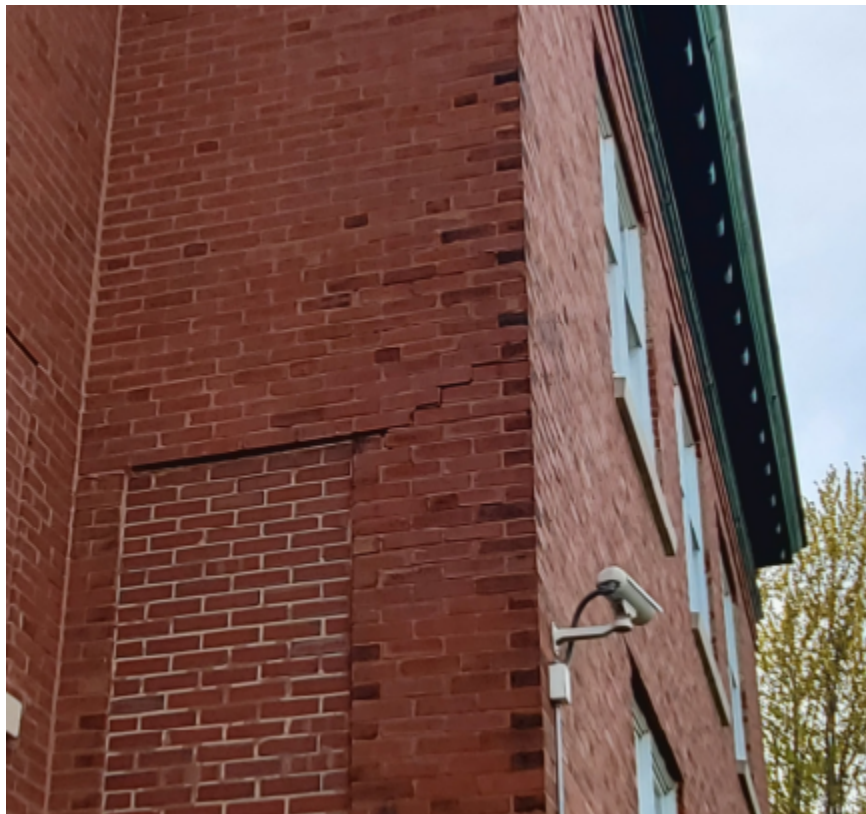
Cracks above In-filled Windows Due to Lintel Corrosion

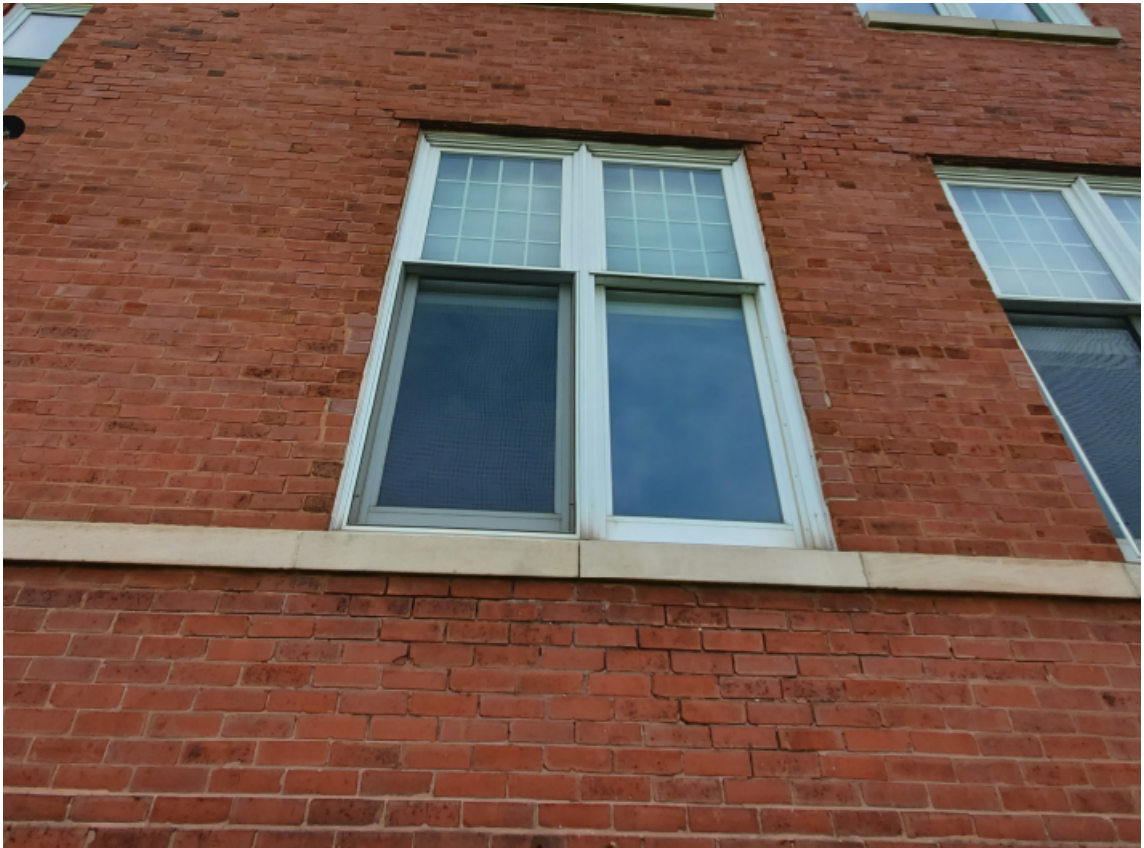
It was noted that some of the areas below the windows have deteriorated masonry. We believe that this deterioration is due to water infiltration, perhaps at the sill of the window, and is not related to any possible issues with the foundations.

Masonry Deterioration below Windows
