Maywood Public Library District 2023-2033 Capital Needs Assessment

FINAL - August 2023

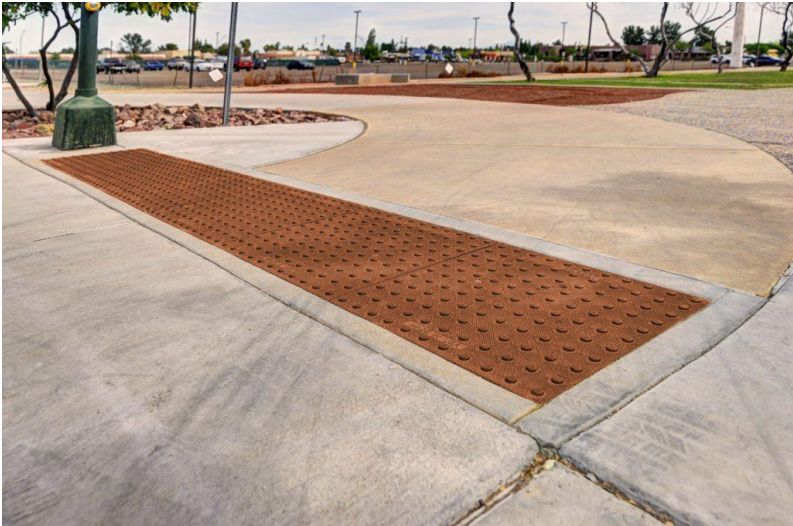
5. Sidewalks crossing driveways lack detectable warning surfaces in contrasting colors from sidewalk surfaces.

Fig. 4- Example of detectable tactile warning surface at locations where pedestrians cross paths of vehicular traffic.

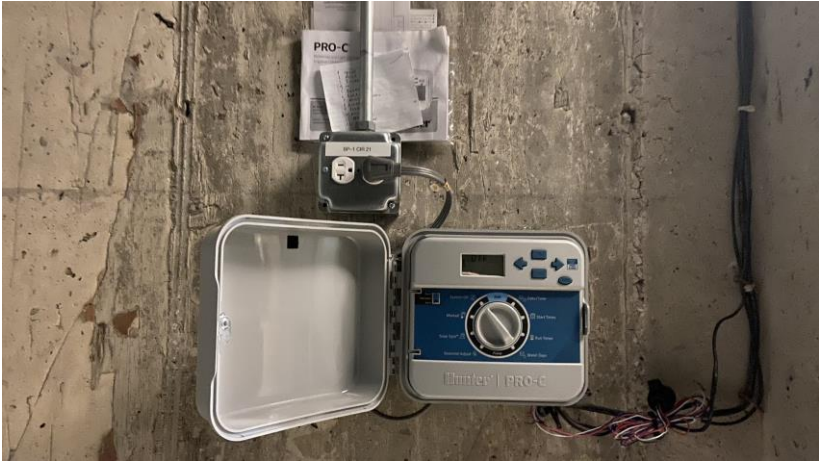
6. A landscape irrigation system is provided with the controller located in the basement along the south wall. Staff reports the system is operational and in working order. Entering into an agreement with a company to perform annual maintenance is recommended.

Fig. 4a- Irrigation system controller.

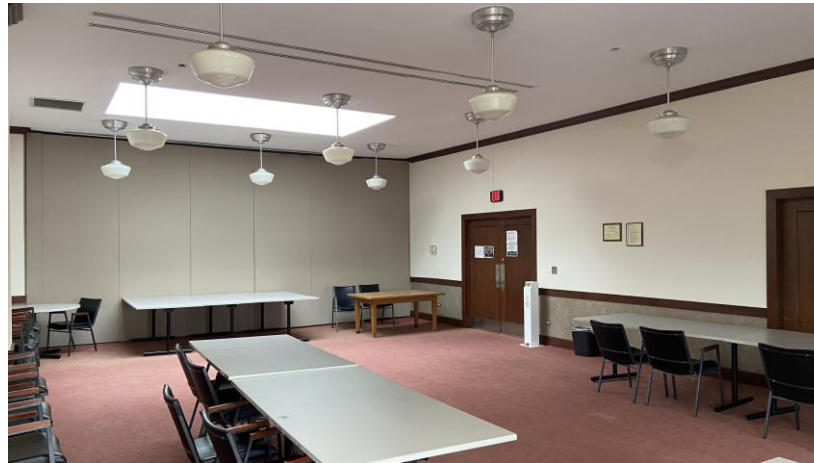
Fig. 22 - south half of main meeting room

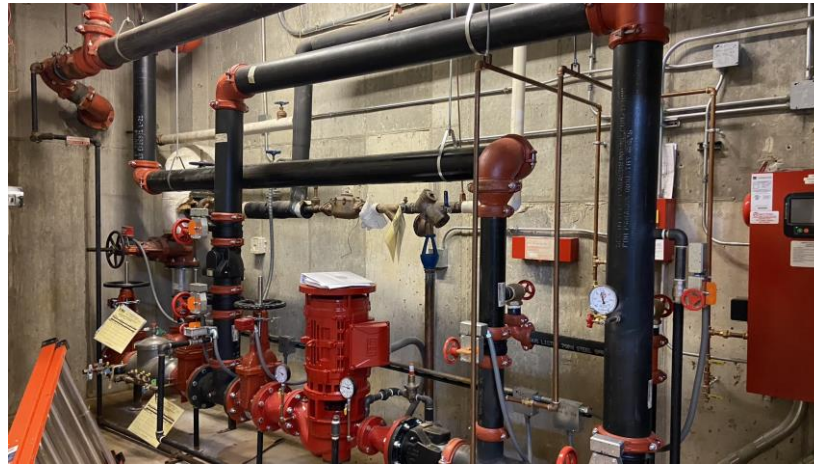
1. Most of the building's fire protection infrastructure was recently replaced along with electrical and HVAC systems. A separate fire protection water service enters the building at the basement level, with a fire pump provided to increase water pressure from the municipal system. A backflow/backpressure prevention device is provided as required by code.

Fig. 24 - incoming fire protection service, fire pump, backpressure prevention device, and pump controller.
